Notes on the Brett Fountain
In the Upper Arboretum, Ipswich

Visited by Bob and Caroline Markham, 28.01.10

Inspection Report

28.01.10

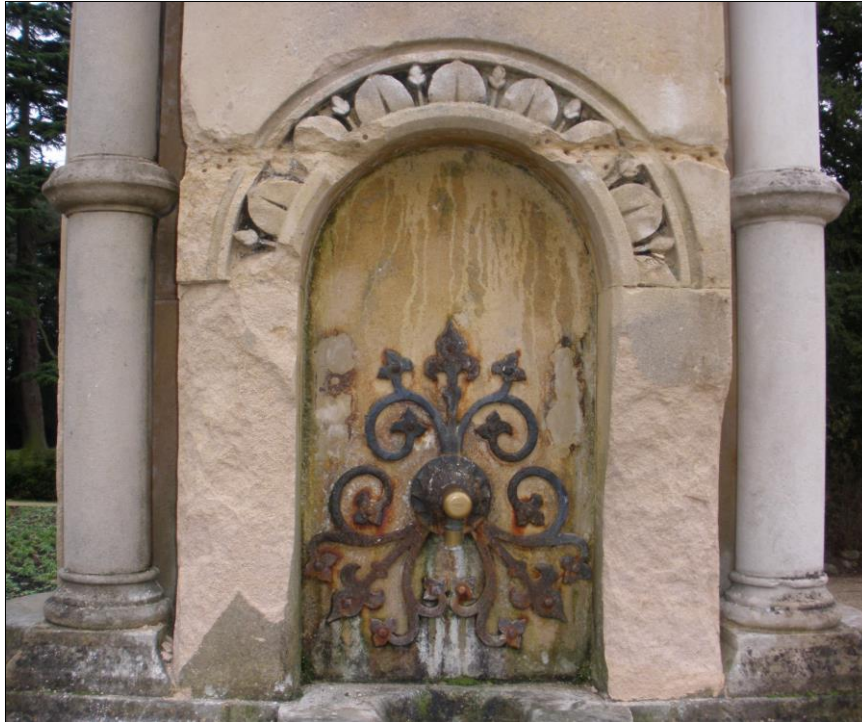
Spalling mainly affects the sides of the lower level block on the north face and the northern side of the lower level block on the west face where the upper level block now projects above it; there is cracking parallel to the stone surface on the north and west faces, showing where pieces will fall from in future. Spalling has also affected the upper level blocks on the north and west faces where they rest on the affected lower level blocks.

Spalling has happened on the north-facing aspects of the fountain and will have been in response to the recent cold weather, having no doubt been plastered with snow, with ice forming inside the damp rock leading to mechanical failure. Similar spalling has happened this winter at other sites.

The upper level block on the north face contains a 2-3cm thick bed of non-oolitic material, with a slight tilt outward, and well seen across the curve of the arch (see illustration). This has weathered noticeably and has holes (?origin) in it.
