Introduction

GEO Suffolk

goes to

church in Coastal Suffolk

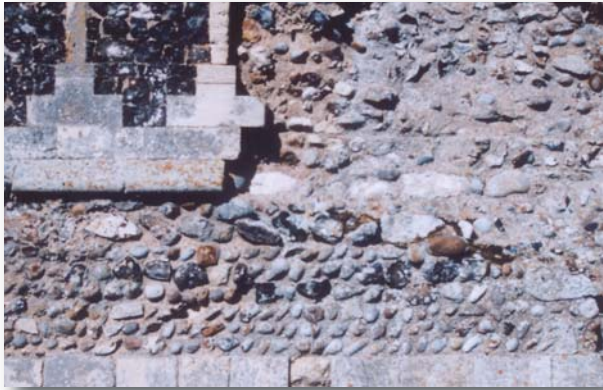
The flint rubble wall at Leiston Abbey.

Flints are widely used. They were readily available from beaches and used as cobbles bound with lime mortar to make rubble walls, and then faced with dressed stone. The ruins at Walberswick church and Leiston Abbey show this well. Flints were roughly dressed by splitting, or finely worked by knapping, as seen in the beautiful flushwork at Ufford and Woodbridge churches.

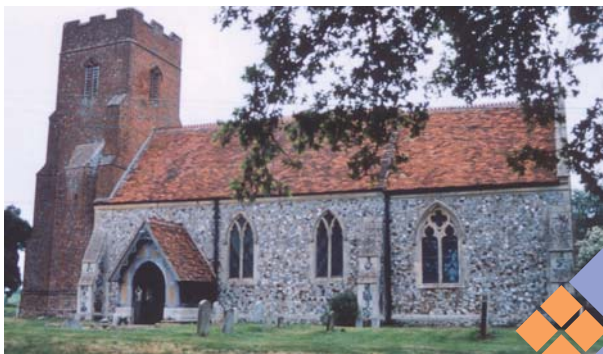
The early brick tower and 'exotos' church at Hemley

Bricks were not much used until the reigns of Henry VIII and Elizabeth I, when they became most fashionable - seen for example in the Tudor towers of Waldringfield and Hemley churches. Later, as their use became more widespread, many local clay and brick pits were dug.

Hemley church, restored in the mid-C19th, is another excellent example of 'exotics' use.

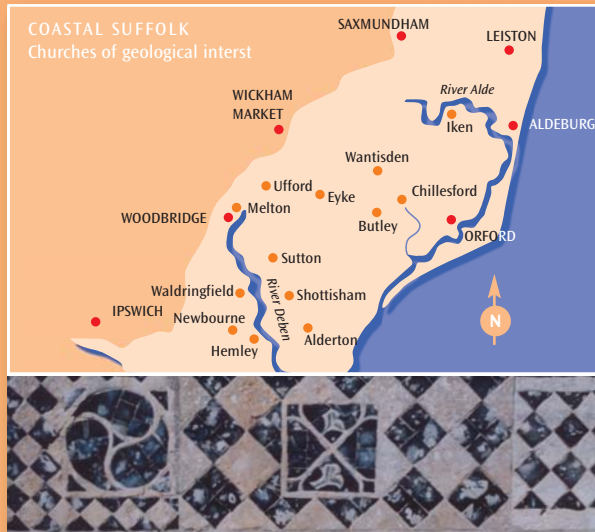
Fine flushwork at Walberswick

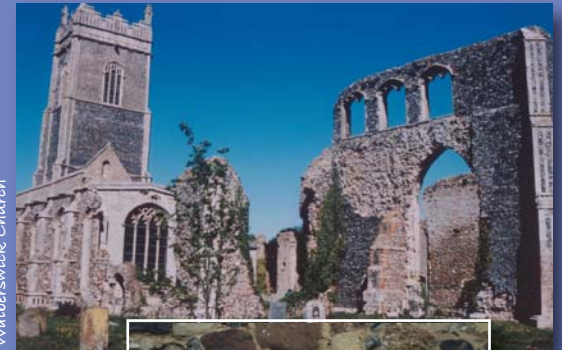
Walberswick Church

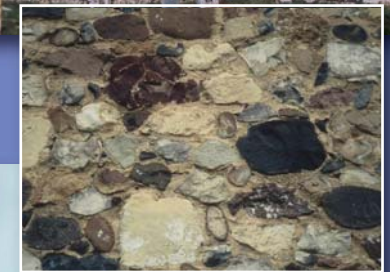
Exotos at Burwicks Church

Dunwich church was clad in stone in 1839 and over 20 different types of stone can be found. They are mostly flints from the beach and septaria, with Caen stone around windows and doors. Many of the roughly dressed stones are 'exotic' and include red, pink and white granite, black dolerite, basalt and gabbro, white and pink quartzites, gneiss, slate, gritstone, several types of sandstone and limestone, and chalk.

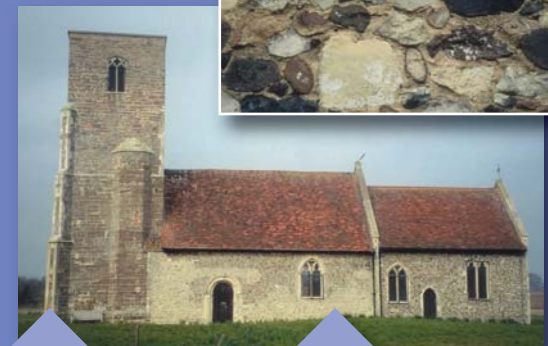
The Coralline Craig tower at Wantisden Church

The best examples are found at Wantisden and Chillesford churches where the towers were built of sawn blocks during the mid-14th Century. Blocks used for recent restoration at Chillesford came from a pit near Sudbourne.

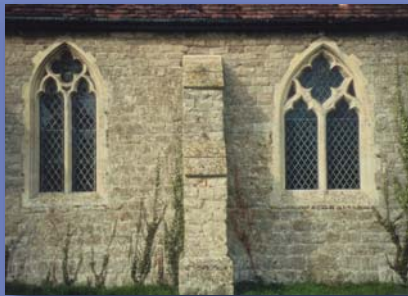
Kentish Rag chancel at Iken Church

This ragstone is a green/brown sandy limestone from the Hythe Beds (Lower Greensand) of the Kent Weald. It was used in Roman times as building stone in London and is widespread in North Kent, but rare in Suffolk. A Victorian fashion, it can be seen making the chancel of St Botolph's, Iken, built in 1853; the stone was evidently brought in by boat. St. Andrew's, Melton, built in 1868, is another example; the stone was transported from source by rail.

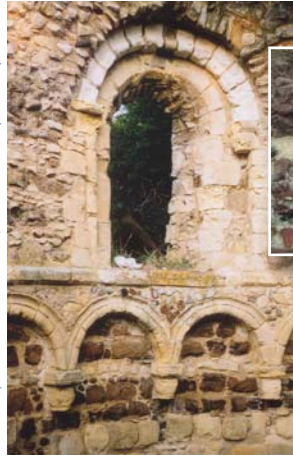
Dark septaria at the ruin of Dunwich Leper Chapel

At Dunwich the stylish Norman/Early English architecture of the Leper Chapel ruin can be seen, with finely carved Caen stone windows and arches and contrasting darker brown septaria.

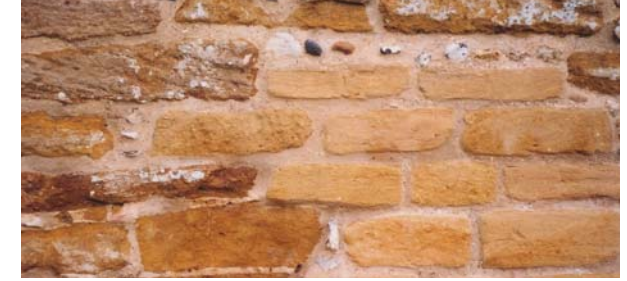
Coralline Crag blocks at Chillesford Church

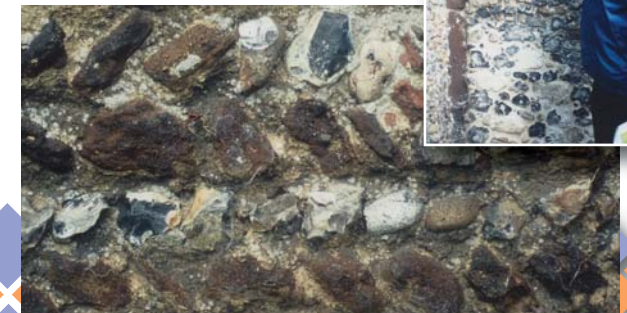
Red Crag 'herringbone' cobbles and quoins at Ufford Church

This Pliocene shelly iron-stained sand outcrops widely over southern Coastal Suffolk. It is commonly used in mortar in many churches. At the east end of the chancel of St Mary's, Newbourne, whole fossil shells from a local pit can be seen. In some localities the Crag sand has been cemented by iron oxides to form an ironstone, which has been used for building. At Ufford church, rough blocks can be seen in herringbone pattern courses (a Saxon style) in the north wall of the nave, and forming quoins.
